ANALYSIS OF RAIL ROUGHNESS ON TRAMWAY TRACK

Krešimir Burnać & Ivo Haladin

This Publication must be referred as: Burnać, K[rešimir]; Haladin, I[vo] (2022). Measurements of rail corrugation on tramway track, Proceedings of the 33rd DAAAM International Symposium, pp.xxxx-xxxx, B. Katalinic (Ed.), Published by DAAAM International, ISBN 978-3-902734-xx-x, ISSN 1726-9679, Vienna, Austria
DOI: 10.2507/33rd.daaam.proceedings.xxx

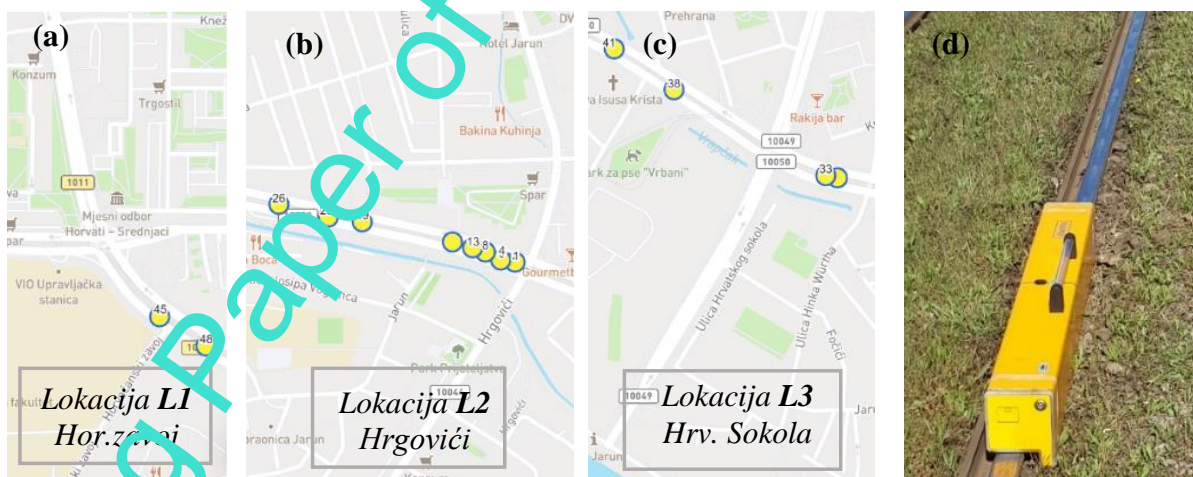
Fig. 1. Locations of railhead corrugation measurement (a, b, c) and manual device for rail roughness measurement (d)

The locations were chosen based on the visual inspection of the track, during which corrugation was noticed. Following the visual inspection, increased levels of vibration and noise were detected near the tram track. Additional criteria selection of the locations was various exploitation time of the rails on the observed locations, various fastening systems, and geometrical elements of the track (straight line and curve) to cover as many track and rail parameters as possible that could be analysed. At each of the locations (L1, L2, and L3), measuring points were located both in a straight line

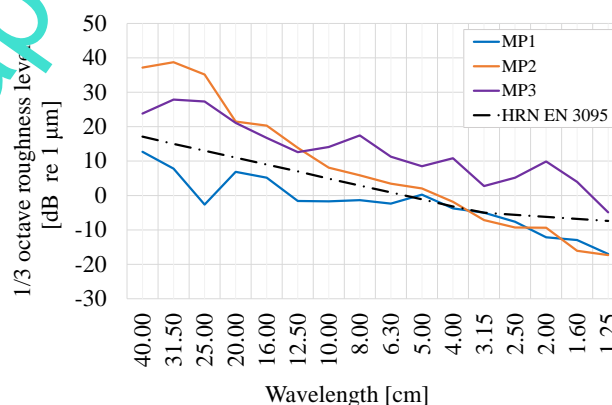
Fig. 2. Railhead corrugation comparison considering the exploitation period

The time-dependent form and development of railhead corrugation are being inspected with the analysis. It is important to emphasize that all the locations are situated on the same tram track section, so the traffic volume is proportional to the exploitation period. Railhead corrugation of the track in a straight line on locations L1 (MP1), L2 (MP2), and L3 (MP3) are displayed in Fig. 2. On the section which has the longest exploitation time (L3, MP3), a higher number of expressed corrugation patterns at wavelengths $\lambda = 2\text{cm}$, $\lambda = 4\text{ cm}$ and $\lambda = 8\text{ cm}$ appeared.

On location L2 (MP2), dominant corrugation wavelengths were from 25 to 40 centimetres (with the highest amplitudes $a = 38.7$ dB for $\lambda = 31.5$ cm). Considering the short exploitation period on location 1 (L1, MP1), there was no railhead folds with dominant wavelengths spotted.

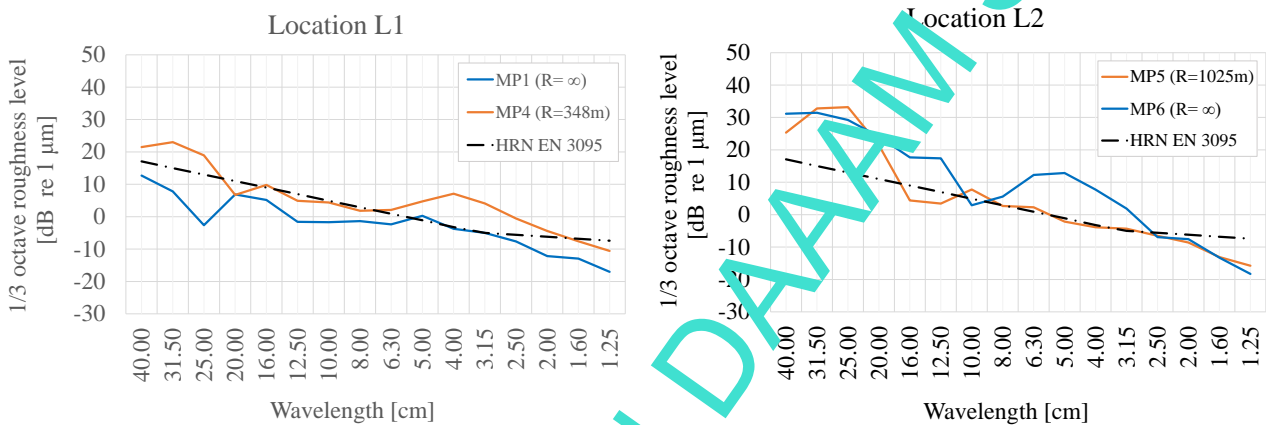
Fig. 3. Railhead corrugation comparison of outer rail in a curve and straight line on location L1 (a) and L2 (b)

Outer rail railhead corrugation was analysed for different curve radii $R = 348$ m (L1, MP4) and $R = 1025$ m (L2, MP5) (Fig. 3.) in comparison to railhead corrugation for track in a straight line at the same measurement locations (L1, MP1 and L2, MP6). With this kind of analysis, it is noticeable that a significant corrugation difference is present with the smaller radius curves as opposed to the corrugation on tracks in a straight line. On the outer rail track with the smaller radius (MM4, $R = 348$ m), a few dominant corrugation wavelengths were detected ($\lambda = 25$ cm, $\lambda = 16$ cm, $\lambda = 4$ cm), while on tracks with bigger radius (MM5, $R = 1025$ m) only corrugation wavelengths around 25 cm with amplitudes $a = 33.2$ dB occur on the tracks. Looking at the rail track in the straight line, almost none of the corrugation wavelengths were dominant in location L1 (MM1), but at location 2 (MM6) there was a visible corrugation development, like the one in the curve with a big radius (MM5), with an additionally emphasized wavelength of 5 centimetres.

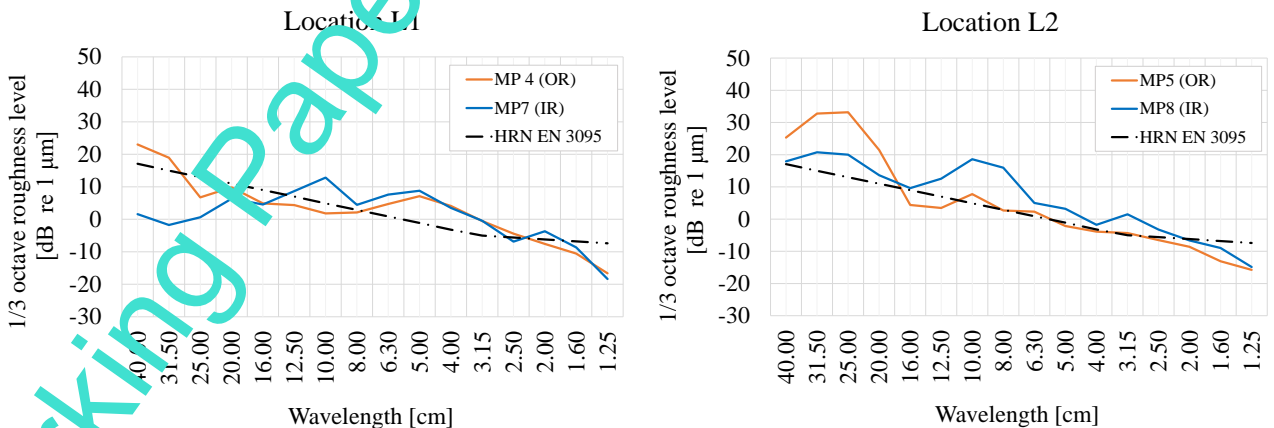
Fig. 4. Railhead corrugation of inner (IR) and outer (OR) rail in curves with different radii on locations L1 (a) and L2 (b)

It is also interesting to observe the corrugation difference between the inner and outer rail on measuring points in a curve because of the different effects of vehicle load coming from the impact of centrifugal force that is present during the circular motion. In Fig. 4., the railhead corrugation of the inner and outer rail for tracks with different curves radii ($R = 348$ m, $R = 1025$ m) is shown. Independent of radius size, bigger corrugation wavelengths were dominant in the 31.5 ($a = 23$ dB) and 25 centimetres ($a = 33.2$ dB) frequency bands on the outer rail (MP4, MP5). On the inner rail (MP7, MP8), shorter corrugation wavelengths from 5 to 10 centimetres with amplitudes $a = 18.7$ dB (for $R = 1025$ m) and $a = 12.7$ dB (for $R = 348$ m) were dominant. Bigger amplitudes occurred on the track in curves with bigger radii (which was not expected). The explanation for this could be the fact that the tram track at the location L2 (MP5, MP 8) has a longer exploitation period than the one at location L1 (MP4, MP 7) and the exploitation period parameter has more effect on the size of the amplitude than the radius size.
