DAMAGE MECHANISM ANALYSIS OF DEVICE FOR THE WAVE SOLDERING

PROVAZNIK, M[artin]; KOLENAK, R[oman] & MARTINKOVIC, M[aros]

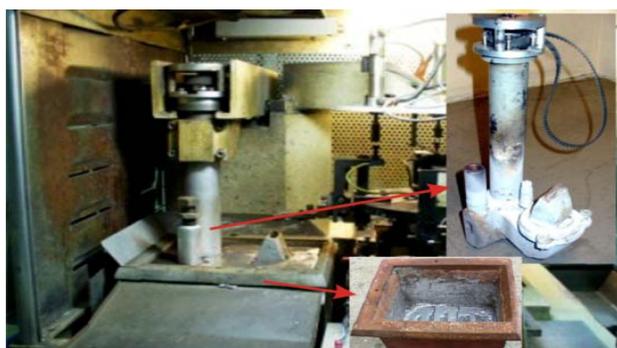
Fig. 1. Equipment for wave formation

Fig. 1 indicate the equipment for wave soldering type Pillarhouse. This equipment was designed by customer's requirements for soldering the terminals of SMD crystals. The wave is formed by an immersion pump located in the soldering bathtub. Bathtub is heated from the bottom by resistance heating elements with a settable range of bath temperature up to 600 °C. Loss of material on the functional parts of this equipment was observed since first application of new solders. The first indications of wear have occurred after 2 to 3 months of service on the parts of pump for liquid solder.

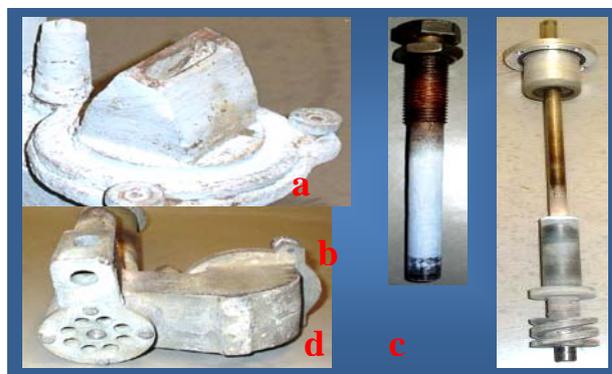
Fig. 2. Parts of equipment for wave formation

The equipment for wave formation consists of the following parts (Fig. 2):

- nozzle - gray cast iron (Fig. 2-a),
- regulation screw - steel, wave height setting (Fig. 2-b),
- worm - gray cast iron, shaft - steel, sucks the solder from the bathtub and forces it through the nozzle (Fig. 2-c),
- equipment block - gray cast iron (Fig. 2-d).

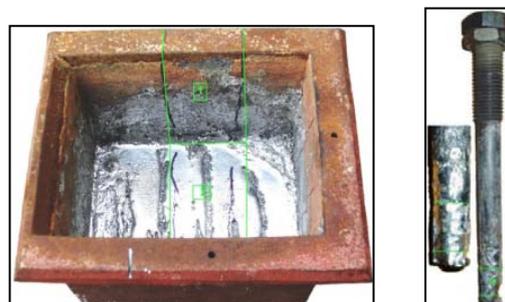
Fig. 3 Sampling from the soldering bathtub and setting screw

Bathtub of soldering equipment (Fig. 3), indicate visible traces of damage after half year of service. After 2 to 3 years the bathtub was perforated and the solder has run out through the hole. In order to prevent the leakage, the soldering bath was preliminary replaced. Analysis of degradation effect exerted on equipment by solder was realised in order to eliminate the need for overall replacement of the damaged parts of equipment.

Samples were taken from the following parts of soldering equipment:

- sample No. 1 - wall of the soldering bathtub,
- sample No. 2 - bottom of the soldering bathtub,
- sample No. 3 - immersed part of regulation screw.

The lead-free solder type SACX0307 (99% Sn, 0.3% Ag, 0.7 %Cu) is used for soldering. Material of soldering bathtub consists of gray cast iron with flake graphite. Material of regulation screw consists of stainless steel type AISI 304 (19.8%Cr, 2.85%Mn, 8.26% Ni).

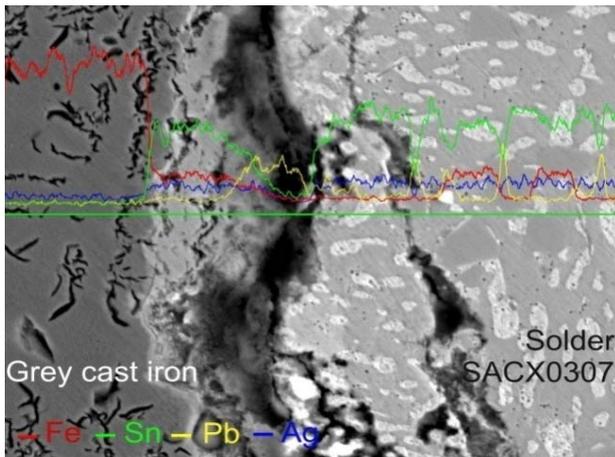
Fig. 4. SEM microstructure - sample No. 1 with quantitative analysis of content of elements

Microstructure of material boundary between soldering bathtub and solder deposit (sample No. 1) is indicate in Fig. 4. There are seen visible reaction products from dissolving the base metal in the solder. Dark grey demarcated grains in the solder matrix indicate an increased presence of iron and tin. Owing to presence of Fe content in solid solution of solder we can consider that erosion of the faying surface of cast iron is concerned. The extent of dissolution is affected not only by the soldering conditions but also by the amount of solder and its composition.

The results of experiments have undoubtedly proved the negative effect of SACX0307 solder on the non-treated parts of soldering equipment. Dissolution of iron in tin matrix is the main cause of wear. Presence of residual lead has resulted from the fact that in the analysed bathtub the lead solders (Sn40Pb) and also lead-free (SAC) solders were simultaneously molten. In order to prevent further wear it was necessary to design the technology for protection of soldeting bathtub and pumping mechanism. Criterion of selection was based on reduced wear of functional parts. Several variants were tested, whereas the best results were achieved by spraying with heat-resistant paints and copper spray. Application of these agents resulted in considerable reduction of degradation effect of lead-free solder on the soldering equipment. This technology is financially less demanding than thermal spraying with ceramic Al_2O_3 coating. Regular treatment prevents the material loss and no peeling of protective coating was observed.

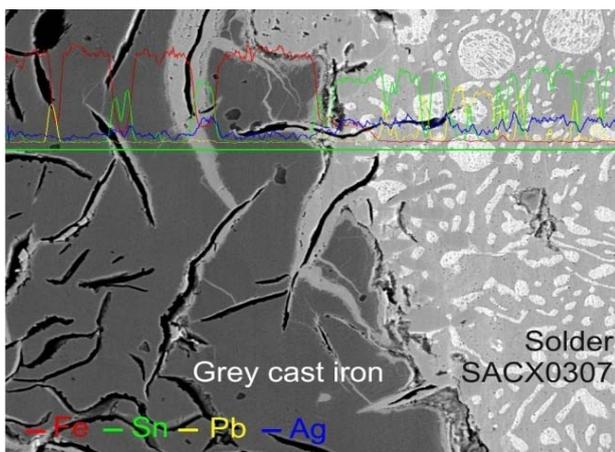
Fig. 5. SEM microstructure - sample No. 2 with quantitative analysis of content of elements

Microstructure of boundary of soldering tub bottom and solder deposit (sample No. 2) is indicate on Fig. 5. Dark grey demarcated grains on the joint boundary and also in solder matrix prove the dissolution of iron in tin and material loss in the soldering bathtub. Also ligh globular phases of lead are seen on the figure.

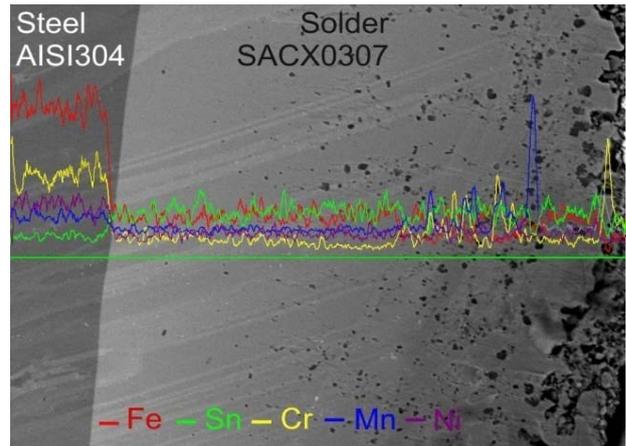
Fig. 6. SEM microstructure - sample No. 3 with quantitative analysis of content of elements

Fig. 6 indicate the microstructure of boundary between the regulation screw and solder (sample No. 3). An increased content of alloying elements Cr, Mn and Ni from the stainless steel was observed in the solder matrix. We suppose that these compounds were released owing to erosion from the faying surface of steel screw by dissolution of iron in tin matrix of the

lead-free solder. These components contaminate the charge in soldering tub and cause an increased reject rate.
