POST SERVICE STRENGTH PROPERTIES AT ELEVATED TEMPERATURE OF STEEL 14MoV6-3

Damir Hodzic, Adi Pandzic

This Publication has to be referred as: Hodzic, D[amir] & Pandzic, A[di] (2018). Post Service Strength Properties at Elevated Temperature of Steel 14MoV6-3, Proceedings of the 29th DAAAM International Symposium, pp.0384-0387, B. Katalinic (Ed.), Published by DAAAM International, ISBN 978-3-902734-20-4, ISSN 1726-9679, Vienna, Austria
DOI: 10.2507/29th.daaam.proceedings.055

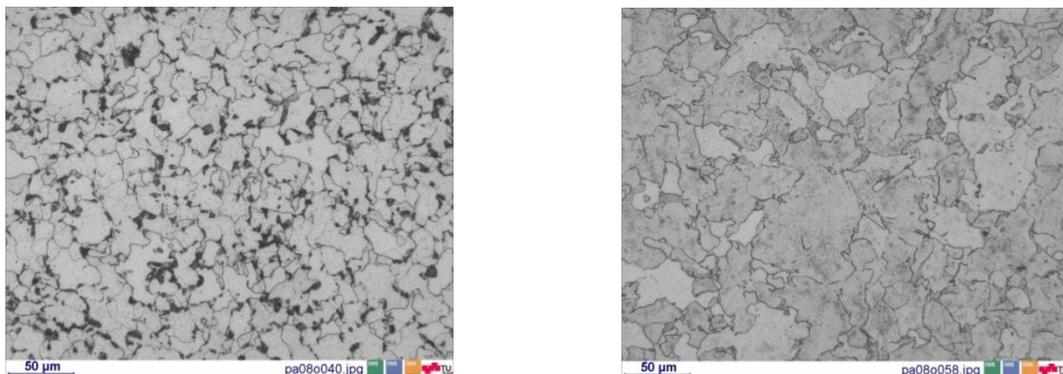
Fig. 1. Microstructure of virgin and exploited steel 14MoV6-3

Initial microstructure of the 14MoV6-3 low-alloyed steel features the mixture of bainite with ferrite, sometimes with a small amount of pearlite and significant amount of the M_3C carbides and numerous, very fine MC type ones. The final structure image after long-term exploitation under service conditions is ferrite with rather homogeneously distributed precipitations inside grains and chains of the significant amount of precipitations on their boundaries, [6]. This microstructure evolution indicates significant decrease of mechanical properties, such as a strength and toughness. It is important to emphasize that metallographic examinations of various steel grades after long-term service at elevated temperature revealed that transformations of carbides and morphological changes of phases have the most significant effect on service properties degradation, [7].

From the results of chemical composition analysis it was obvious that investigated steamline specimens (virgin and exploited) are made of the same material 14MoV6-3. Slightly less content of Molybdenum, comparing with chemical composition according to DIN 17175, is probably error of measuring without influence on further investigation, because content of Molybdenum is almost the same for virgin and exploited steamline material. In order to investigate microstructure of exploited steamline material, metallographic testing was accomplished. This was done in laboratory at IWS Institute TU Graz, Austria, by testing and comparison of microstructure of virgin material and exploited material. Microstructure of investigated steel 14MoV6-3 at transversal cross section of steamline pipe with magnification 200× is shown in Fig. 1, [5].

Microstructure changes under the influence of temperature, stress and environment in exploitation cause the substantial degradation of mechanical properties. In the case of the investigated steel 14MoV6-3 microstructure evolution indicates significant decrease of strength properties, that has to be proved by strength testing.

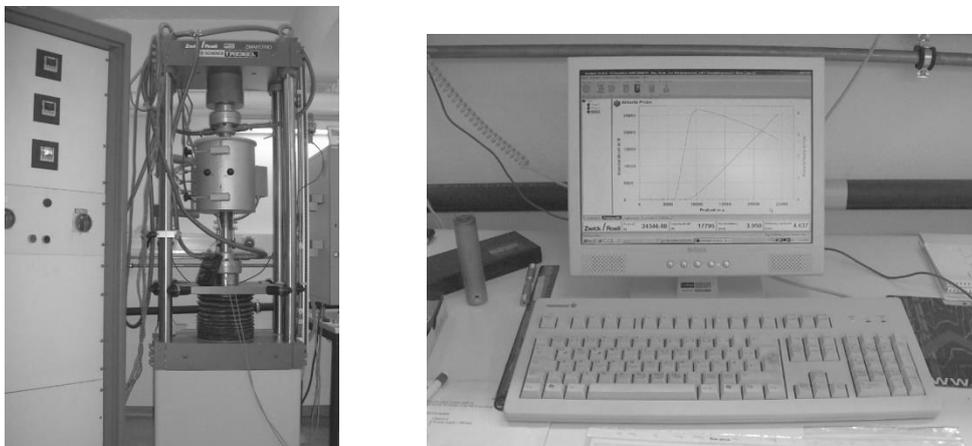
Fig. 2. Testing machine and data acquisition

Slow strain rate test (SSRT) represent a dynamic slowly increasing strain imposed by an external means on uniaxial tension specimen according to ASTM G 129 standard. It is used for relatively rapid screening or comparative evaluation of environmental, processing or metallurgical variables that can affect resistance of material, [8]. Testing was done for two different slow strain rates (0,0001 mm/s and 0,000254 mm/s) with tensile testing machine ZWICK ROELL at IWS Institute TU Graz, Austria. Software for data acquisition was testXpert x2.02.0 ZWICK/ROELL. Number of specimens for testing was one per strain rate and specimens with round cross sections for elevated temperature tensile testing were used. Fig. 2 shows equipment used for slow strain rate test and tensile test at elevated temperature.

Number of testing specimens was one specimen per strain rate and testing was accomplished with the same equipment that was used for slow strain rate test at elevated temperature 540 °C. Testing time to specimens failure for slow strain rate 0,0001 mm/s was approximately 24 hours and for slow strain rate 0,000254 mm/s it was approximately 10 hours.

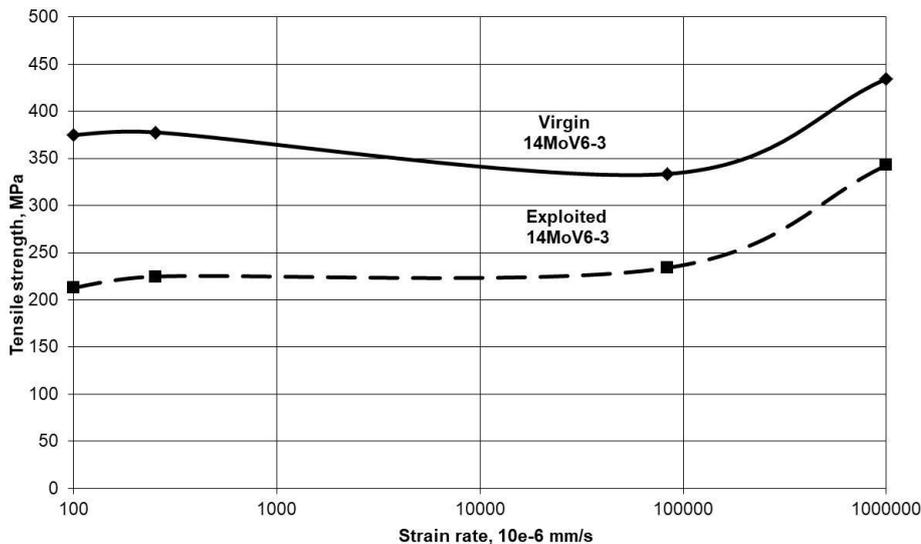
Fig. 3. Strain rate and tensile strength at elevated temperature 540 °C

In addition to the slow strain rate test, tensile testing at elevated temperature 540 °C with high strain rate 1 mm/s and standard strain rate 5 mm/min (0,083 mm/s) for tensile testing is also performed with the aim to investigate dependence between strain rate and mechanical properties (tensile strength) of steel 14MoV6-3. Results of this investigation are given in comparative manner between virgin and exploited steel 14MoV6-3, as shown in Fig. 3.

Considering the presented results of strength properties at elevated temperature of steel 14MoV6-3, as a result of prolonged lifetime in service there is a notable degradation of mechanical properties. Through the testing with different strain rates at elevated temperature 540 °C there is obviously significant decrease of tensile strength and implicitly other strength properties of exploited steel 14MoV6-3 comparing with virgin 14MoV6-3.

It should be noticed that with decreasing of strain rate there is also slightly greater decrease of tensile strength of exploited material comparing with virgin. Implicitly, it means that it could be expected significant decrease of time dependent strength properties like creep rupture strength, but it should be proved by creep testing.
